ctrlX CORE

Runtime

XCR-V-0120

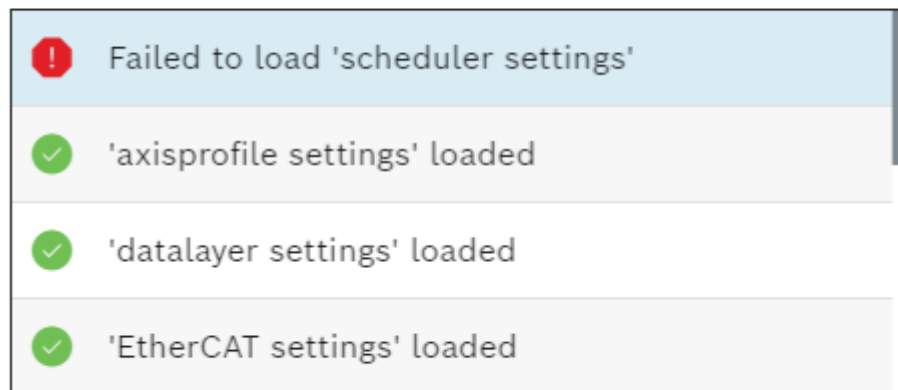
Fig. 2: Bug512533_02.png

[2022-07-20 10:56:30] Loading finished with one failure.
Search for '4BPRj0' to find details in [Logbook](#).

DL_TIMEOUT · original error: DL_TIMEOUT
