# ctrlX CORE

Runtime

Edition	Release	Notes
01	2021-07	First edition ctrlX CORE Runtime version XCR-V-0110

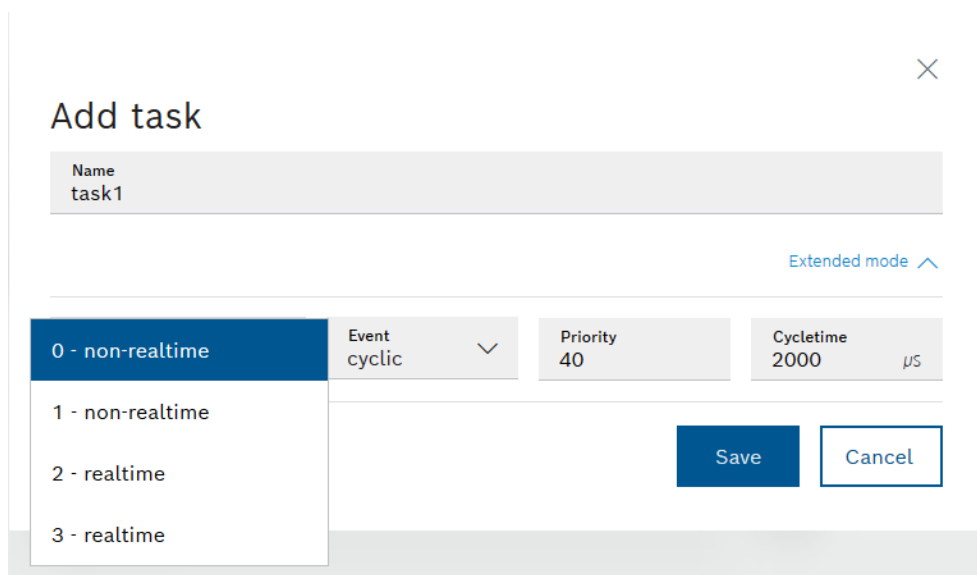
Fig. 1: ctrlX CORE Runtime Release Notes Feature 257709

- Available CPU kernel displays
  - The Scheduler shows the available CPU cores. They are divided into "real-time" and "non-realtime".  
DL URL: "*scheduler/admin/info/cpu-cores/total*"
  - realtime: These CPU cores are reserved for the application "automation.core". The best real-time capability is ensured.  
URL: "*scheduler/admin/info/cpu-cores/realtime*"
  - non-realtime: These CPU cores are available for all applications and for the operating system. The real-time capability, e.g. by interrupts, cannot be completely ensured on these CPU cores. These cores are used by the operating system and should not be too highly loaded by tasks with real-time priority to ensure the operability of the system.  
URL: "*scheduler/admin/info/cpu-cores/non-realtime*"
